ADVISORY CIRCULAR 43-16A

AVIATION MAINTENANCE ALERTS

ALERT
NUMBER
303

OCTOBER
2003

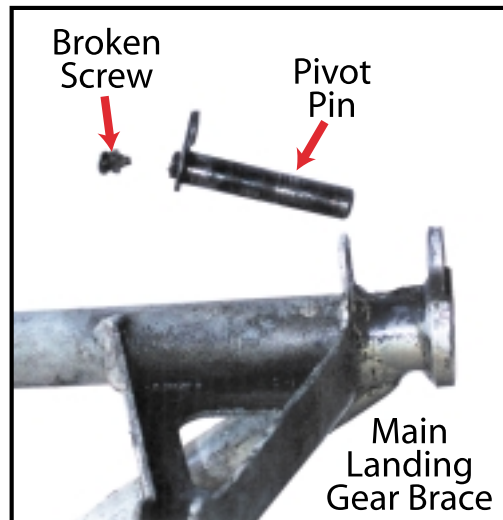
Beech; Model 95-B55 (T42A); Baron; Main Landing Gear Retract Brace Failure; ATA 3230

The right main landing gear collapsed during the rollout and damaged the right flap, wingtip, brake assembly, and propeller.

The technician discovered the screw (AN515-8-8), which secures the landing gear retract brace pin in place, broke and allowed the pin to back out. The retract brace became loose and allowed the downlock to unlatch. (Refer to the illustration.)

A search of the FAA Service Difficulty Reporting Program data base revealed five additional reports with like failures.

Part total time-6,350 hours.

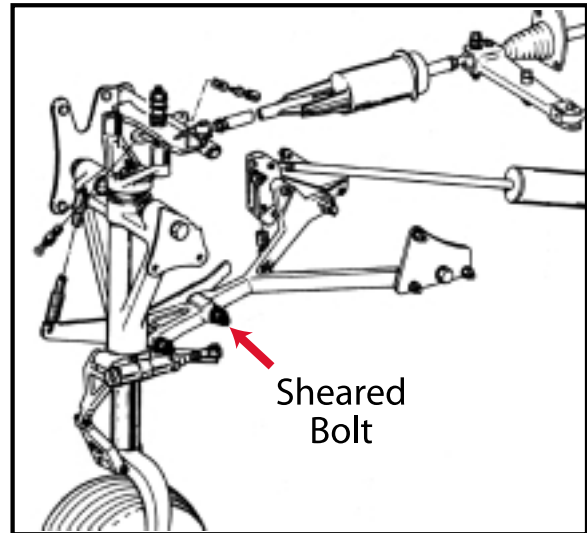
PIPER**Piper; Model PA-44-180; Seminole; Nose Landing Gear Center Drag Link Bolt Failure; ATA 3230**

During touchdown the nose landing gear collapsed resulting in damage to the nose of the aircraft, both engines, and both propellers.

After examining the nose gear, the technician discovered the center drag link bolt (NAS464P4-27) was sheared in the center and the downlock hook was broken in half. (Refer to the illustration.)

Part total time-5,942 hours.

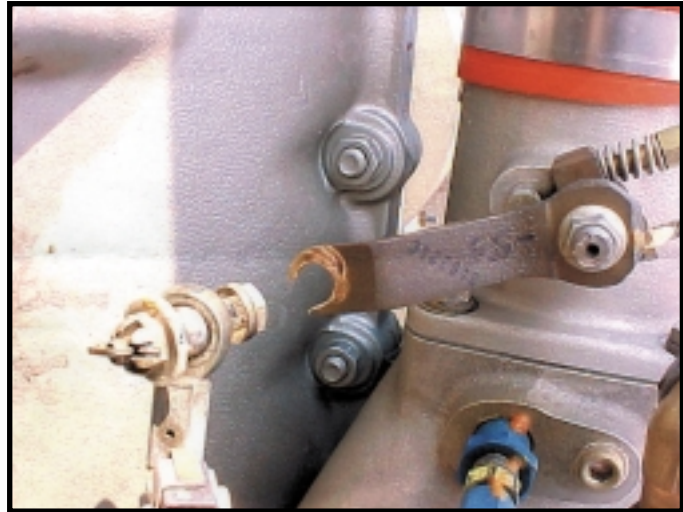
Teledyne Continental Motor; Model IO-550-G; Throttle Control Lever Failure; ATA 7322

A Malfunction or Defect Report stated that the throttle control lever (P/N 646224A) wore out at a bolt hole and caused the throttle cable to come free. (Refer to the illustration.)

According to the submitter, the pressed in bushing at the end of the throttle arm failed.

Part total time-322 hours.
